# Manhole Inspection Summary

Manhole # S59I\_\_007MH

Insp Date: **9/9/09 9:05 AM**

**Location** Address: **Portugal St.**

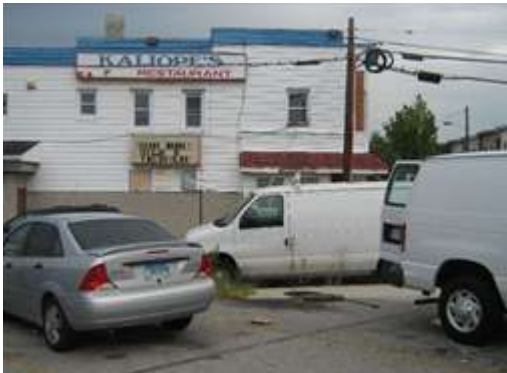
Location View

View facing north

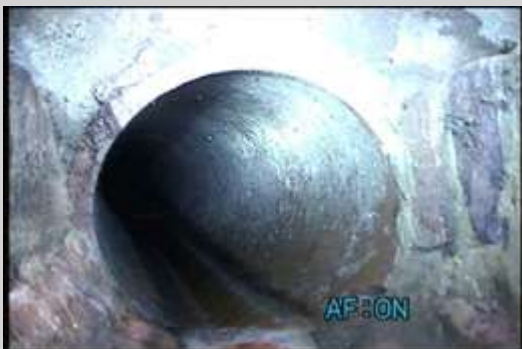
7 O'Clock Inflow

Pipe Height: **8.4** (in.) Rod and Bar (Angled)  
Pipe Material: **Clay** ☐ Pipe Lined  
Invert Depth: **7.90** (ft.) Flow Characteristics: **None**  
Deposits: ☒ None ☐ Mud ☐ Sludge ☐ Debris ☐ Grease  
Silt Depth: **0** (in.) Deposits Extent:  
Infiltration: **None** Pipe Seal Cond: **Sound**
